**BUILDERS' SERIES**

# ***Drywall Application***

# **Drywall Application**

The information in this guide is not intended as a complete course in drywall installation. Rather, it attempts to identify the most common problems, probable causes and recommended solutions.

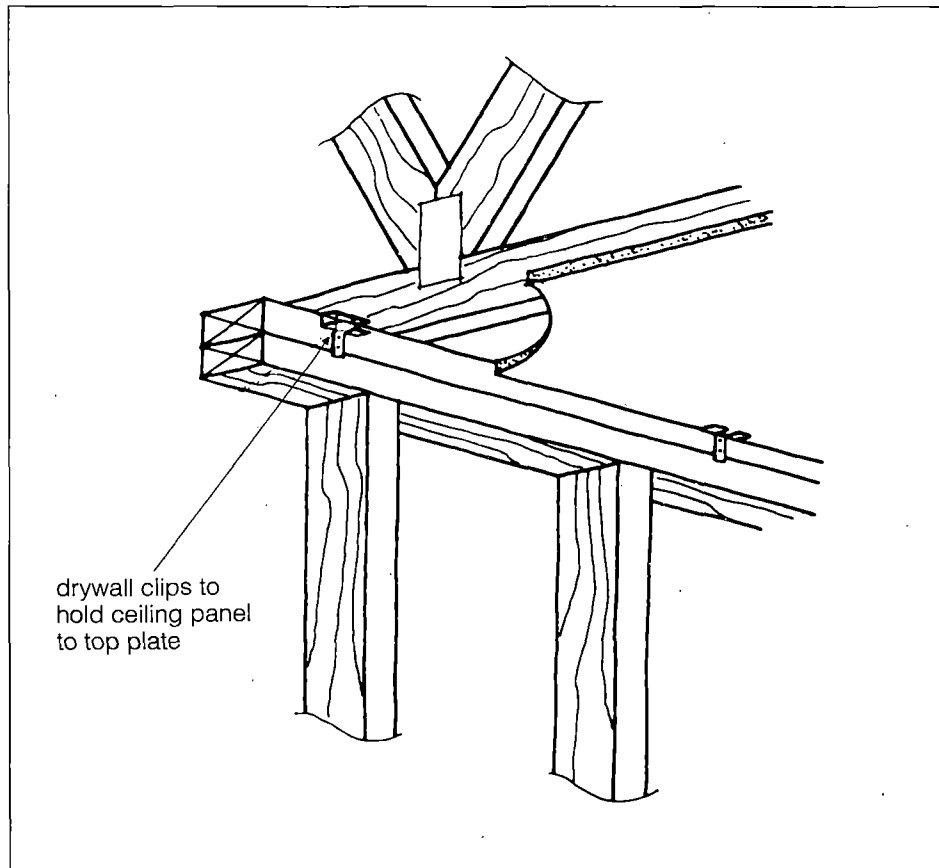
Fig. 9. Drywall clips

- With floated corners, double the first row of fasteners to prevent pull-through.
- Ensure strong corner joints. Avoid scoring paper tape with the trowel. Joints made with fibreglass tape are approximately twice as strong as those with paper tape.
- Reduce the stress on corner joints by holding the ceiling drywall to the top plate with drywall clips, with wood blocks or with wider top plates and strapping. Drywall clips can be attached to the ceiling drywall or to the wall framing before the drywall is installed. Clips are usually spaced at 600 mm (24"). Consult manufacturers for recommended installation practices (*fig. 9*). Some builders have also used cornerbead to hold down the ceiling boards

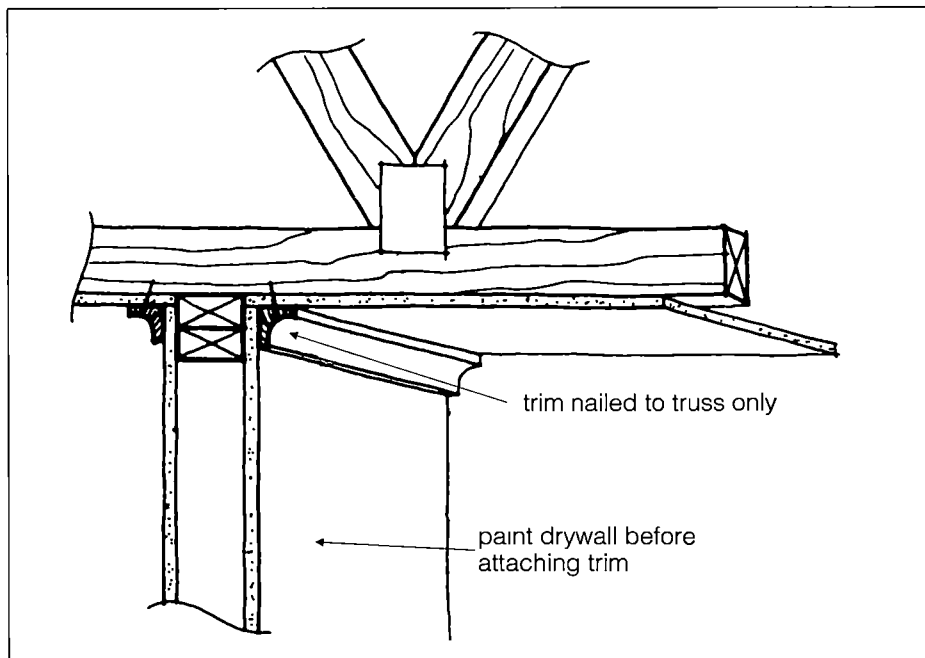
- If truss uplift occurs, fasteners in the ceiling drywall near the corner joint can be driven through and the joint retaped to create a floating corner. Alternatively, mouldings can be attached to the ceiling (not to the walls) to cover the crack at the joint and to create a slip joint (*fig. 12*). Do not attempt to remedy truss uplift by driving wedges between the trusses and the partition walls. This can cause serious structural problems when the truss settles later.

Fig. 12. Slip joint

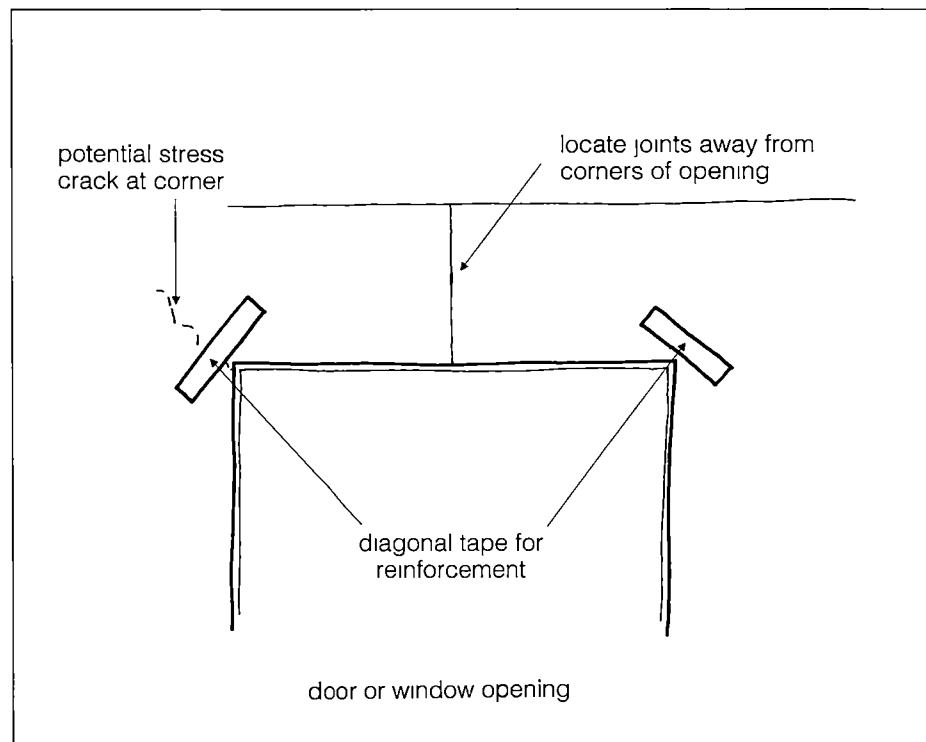
- Avoid locating joints at the edge of the header (fig. 16).
- Provide adequate framing to absorb vibration from door and window operation. Cut jack studs accurately.
- Apply 150-200 mm (6"-8") lengths of joint tape diagonally to reinforce corners (fig. 16)
- Extend header beyond edge of the door opening.
- With metal framing, reinforce header/jamb intersections, or provide additional strut studs. Grout frames for heavy or oversized doors.

Fig. 16 Preventing stress cracks

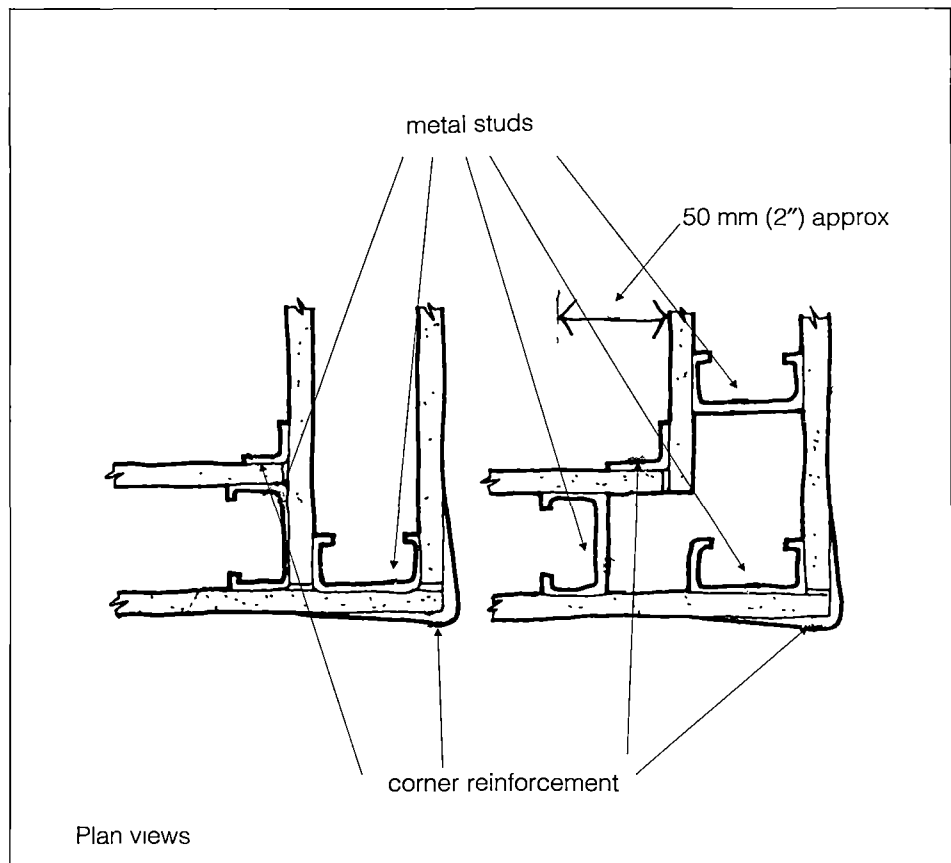
Fig 18. Interior corners with metal studs

- Avoid single-stud corners unless drywall clips are used. Provide adequate nailing surfaces, especially at interior corners (fig. 17).
- With metal studs, run drywall from the interior of the corners through to the outside face (fig. 18).

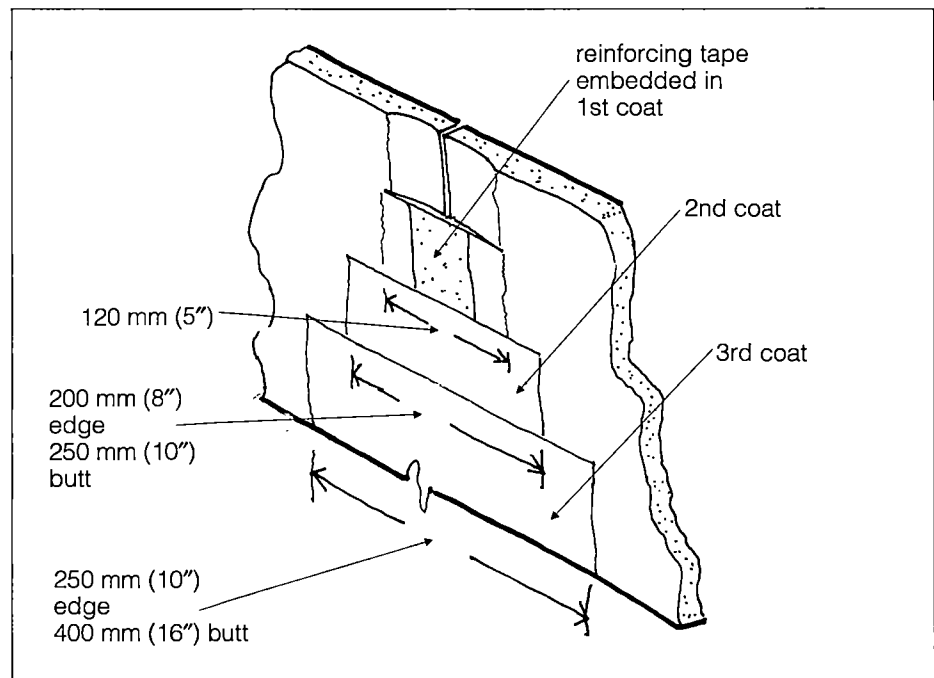
Fig. 21. Typical joint treatment

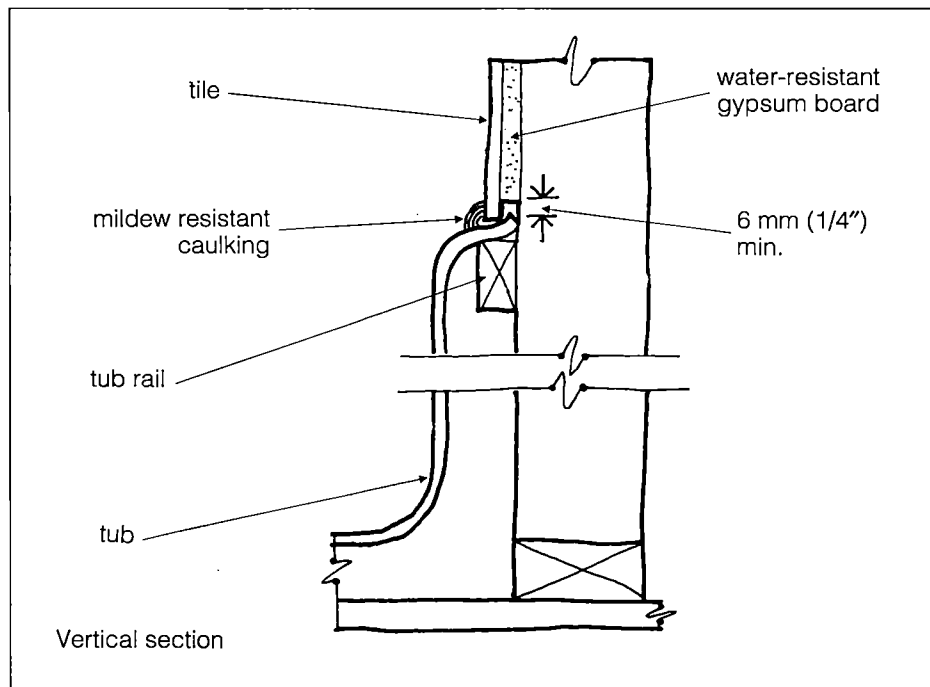
Fig. 24. Bathtub detail

- Use water-resistant gypsum board in damp areas. The National Building Code now requires "moisture-resistant backing" for ceramic tile. Regular board cannot be used.
- Allow 6 mm (1/4") space between the drywall and the surfaces of the tub, shower floor or return (fig. 24).
- To prevent problems at the bathtub, some builders use a cement-based board instead of gypsum board as an underlay for ceramic tile, or they install a fibreglass tub enclosure.
- In exterior applications such as soffits, use frequent control joints, and allow a 6 mm (1/4") space from all abutting vertical surfaces.
- Some builders strap bathroom walls to allow an airspace for improved drying.
