Save Energy and Extend Building Life— Window and Balcony Door Replacements

OCH identified five suitable multi-unit residential apartment buildings for window and balcony door replacements: 280 Rochester, 380 Murray, MacLaren Towers (415 MacLaren), Golden Manor (445 Richmond)¹ and Bellevue Manor (1465/1485 Caldwell) (table 1).

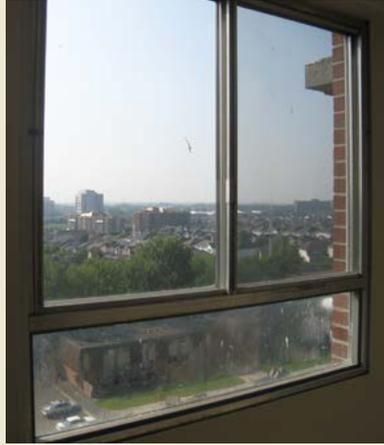
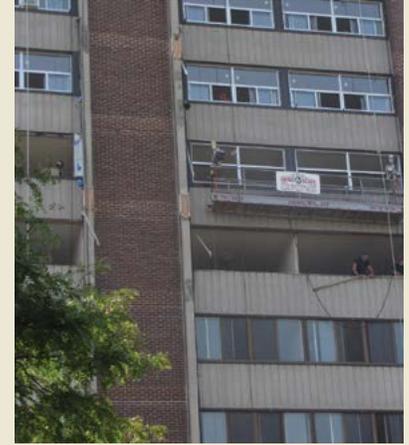
Total cost of retrofit: \$15.5 million across all five buildings (\$12,128 per unit)

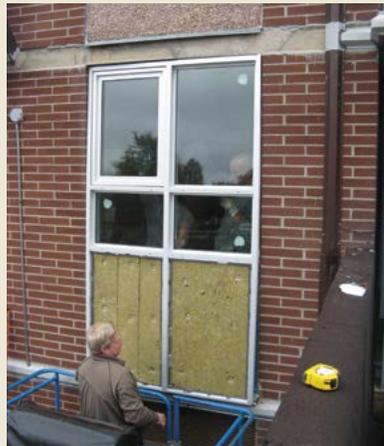
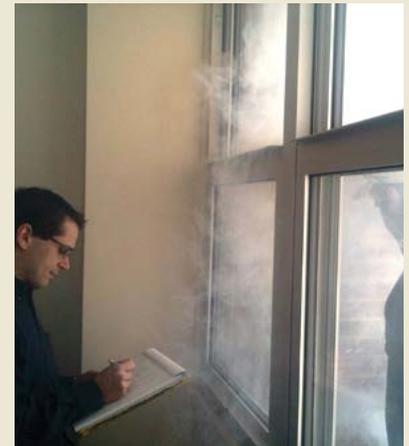
Windows and balcony doors: replacement cost between \$1.7 and \$4.9 million per building

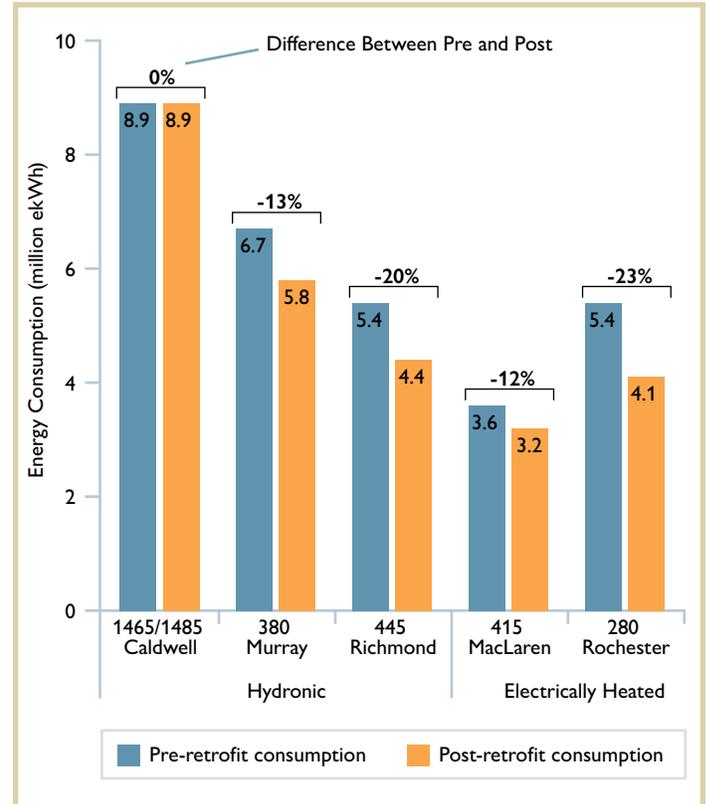
Figure 1 Pre- versus post-retrofit energy consumption

In the 12 months prior to the retrofits, the total energy consumption of the buildings was approximately 30 million equivalent kilowatt-hours (ekWh).² In the 12-month period after the retrofits were completed, energy consumption decreased to 26 million ekWh (figure 1),³ saving \$145,000 in costs.⁴ Replacing the windows and balcony doors resulted in average energy savings of 14 per cent. Each property reduced its energy intensity by between 0 to 6.5 ekWh per square foot per year (table 2).

Replacing the windows and balcony doors resulted in average energy savings of 14 per cent.

Figure 1: Pre- versus post-retrofit energy consumption
